section *eight*

Cemetery Design Guidelines

Following are guidelines for the preservation and restoration of the Memory Hill Cemetery in Milledgeville's historic district. This section provides guidance to volunteers, caretakers, and nonprofit organizations that have an interest in preserving the National Register listed cemetery. These guidelines offer technical information regarding historic materials and appropriate restoration methods.

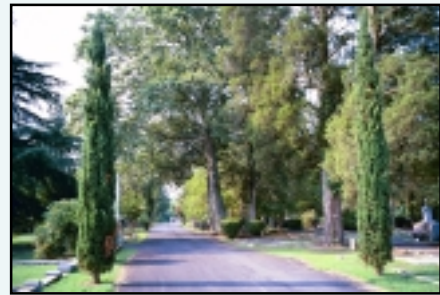
Planned features such as tree-lined access roads and historic fencing should be preserved.

The layout of a cemetery including the gravestones, plants, and furnishings are an important feature of nineteenth century cemeteries. Focal points and axis are defining features and should not be disturbed. The use of evergreen trees in nineteenth century cemeteries often represented eternity. Other plants also had symbolic meanings. Mature plants should be maintained. The introduction of non historic materials can alter the historic character of the cemetery. The construction of new paths which destroy the layout are not advised.

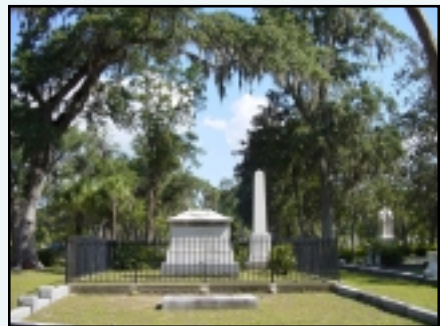
The family plot shown above has a marble monument, cast iron fence and plantings that are elements that make up the character of the plot.

Elements of a grave may include a headstone, a footstone, grave plantings, ornaments, and furniture. The elements of a grave may have a social context as well as a aesthetic context and should be preserved.

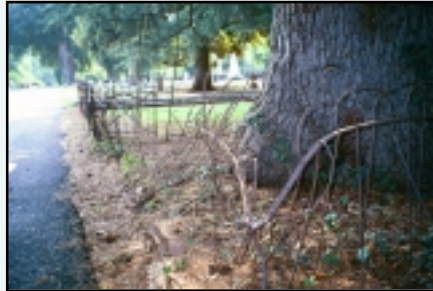
This wire fence has been damaged beyond repair. Replacement with a similar fence is recommended.

Fences add to the visual quality of a cemetery and should be retained. All of the fences in the Memory Hills Cemetery are metal. Damaged fences should be repaired and maintained.

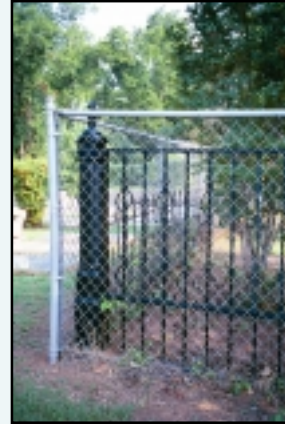
Chain link fencing is a modern intrusion into the historic cemetery.

8.1.6 Chainlink, vinyl, and wood fences are not appropriate to the character of the cemetery.

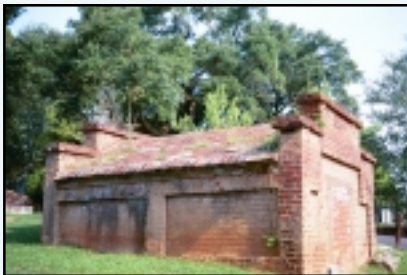
Weed trimmers and power mowers can damage fragile gravestones by throwing debris and scarring the stone. Chemicals can splash onto stones and cause deterioration. Overgrown plants can slowly deteriorate stone and should be pruned annually.

Lack of routine maintenance has allowed vegetation to seriously damage this brick vault. Invasive vegetation should be removed by hand and historic masonry repaired by a professional.

8.1.10 Vegetation which keeps stones and walls damp or is causing damage should be cut back or removed.

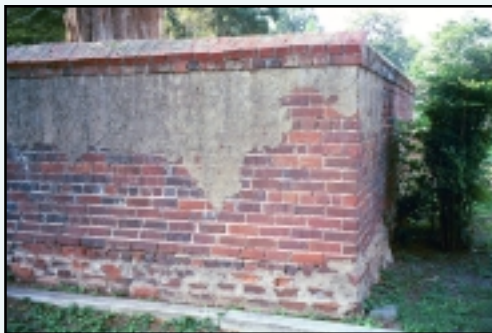
This wall has been inappropriately repointed with Portland cement that extends beyond the original mortar joints.

8.2.4 If stone or brick needs repointing, new mortar should duplicate the historic mortar in color, texture, and strength. In most cases a mortar with a high Portland cement content will damage historic bricks or stone.

A person untrained in conservation practices should never attempt the repair of historic monuments and gravestones. Irreversible damage can occur. The use of a mortar which is stronger than the original historic mortar will damage historic brick or stone with changes in temperature and should be avoided at all costs.

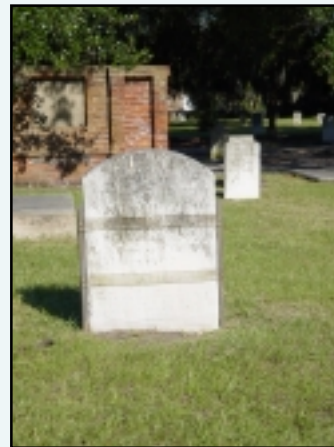
An example of a Savannah gravestone that has been reset in place by professionals.

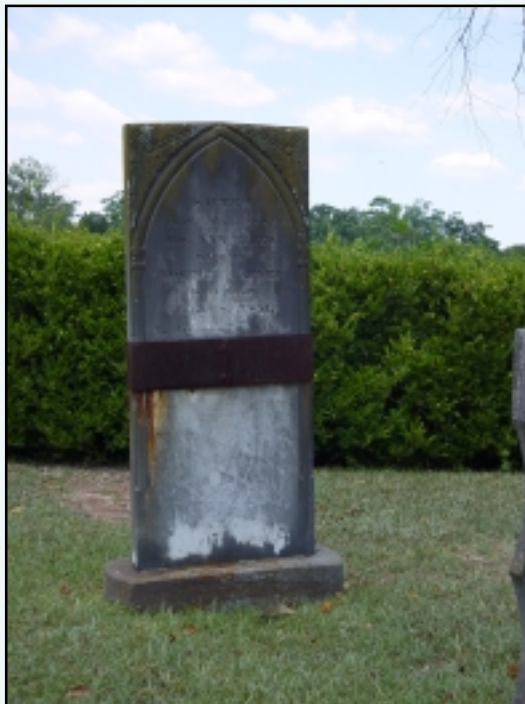
This stone has been improperly repaired. Metal clamps should not be used to hold a broken stone together as staining and further deterioration will result.

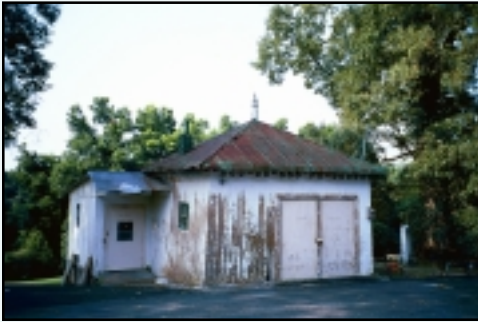
The Memory Hills Cemetery has two historic accessory buildings in fair to poor condition which are significant features of the cemetery. The care and rehabilitation of these buildings should follow the residential rehabilitation guidelines in this manual.

This accessory building at Memory Hills Cemetery is in poor condition and is in need of repair.
